September/October 2012  
Vol. 25, No. 5

# HIGH-PERFORMANCE FIBER-REINFORCED CONCRETE JACKETING IN A SEISMIC RETROFITTING APPLICATION

BY DARIO ROSIGNOLI, FRANCESCA SIMONELLI, ALBERTO MEDA, AND ROBERTO ROSIGNOLI

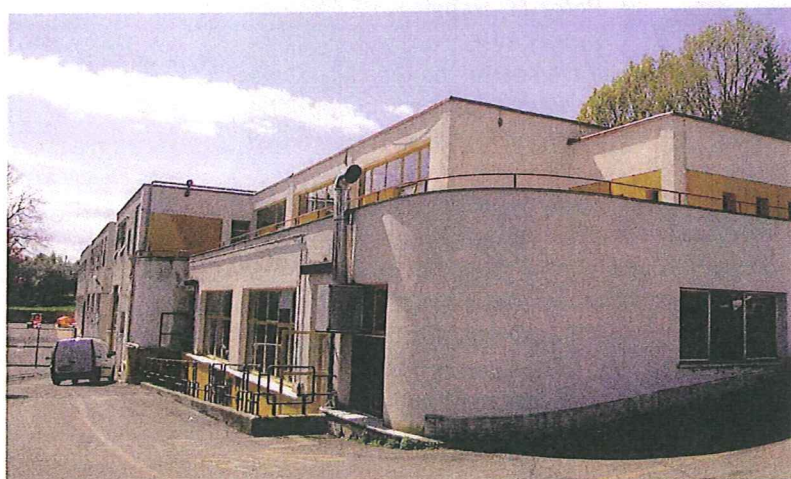
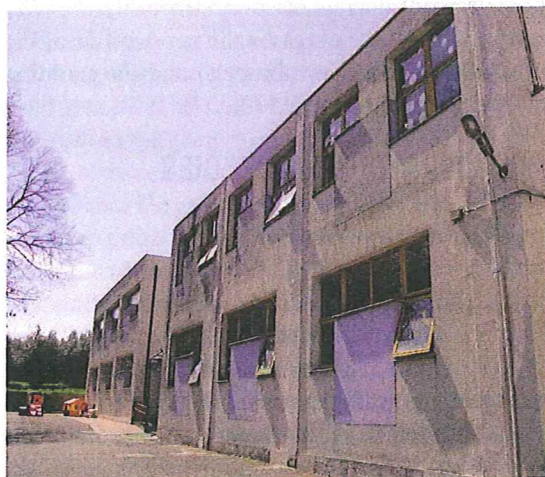
Fig. 1: Overall view of the outside Zagarolo School near Rome, Italy

The proposed technique was used in the following real case study. The project involved a school building located in a seismic area near Rome (Fig. 1), where tests showed that concrete with an average compressive strength of 1600 psi (11 MPa) had been used. Because of the low strength of the existing concrete, a complete retrofit of the building had to be undertaken to comply with new Italian seismic codes.

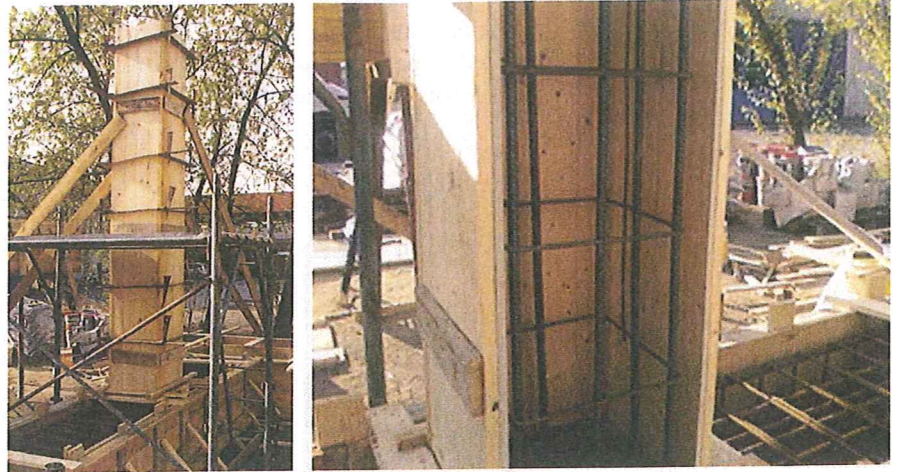
Fig. 2: Column geometry and specimen construction

A column with a 16 x 16 in. (400 x 400 mm) square cross section was tested (Fig. 2). The 10 ft (3 m) high element was cast on a 20 in. (500 mm) thick foundation. The reinforcement and concrete strength were typical of this kind of element in the 1960s and consisted of 0.6 in. (16 mm) diameter longitudinal reinforcement steel and 0.3 in. (8 mm) diameter stirrups spaced at 12 in. (300 mm) with a concrete strength of approximately 2900 psi (20 MPa) (Fig. 3).

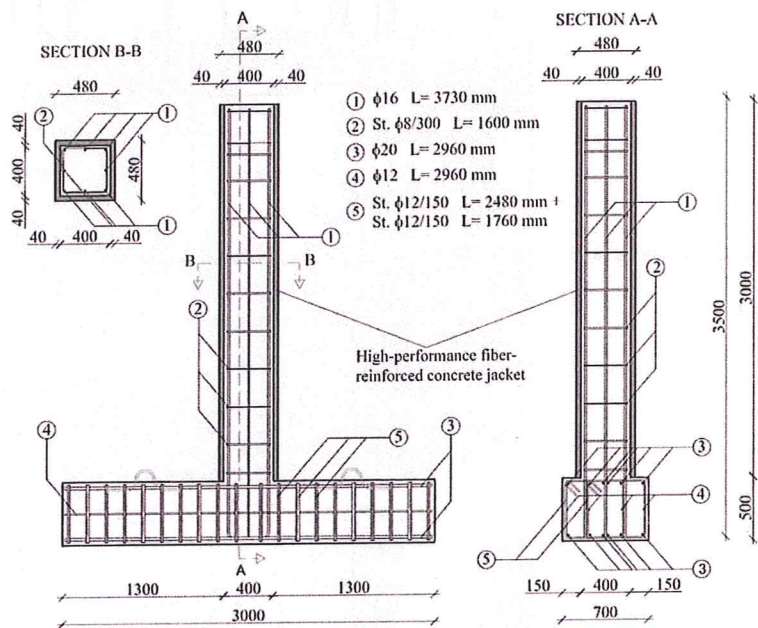
Fig. 3: Details of the specimen construction. (Note: 1 mm = 0.039 in.)

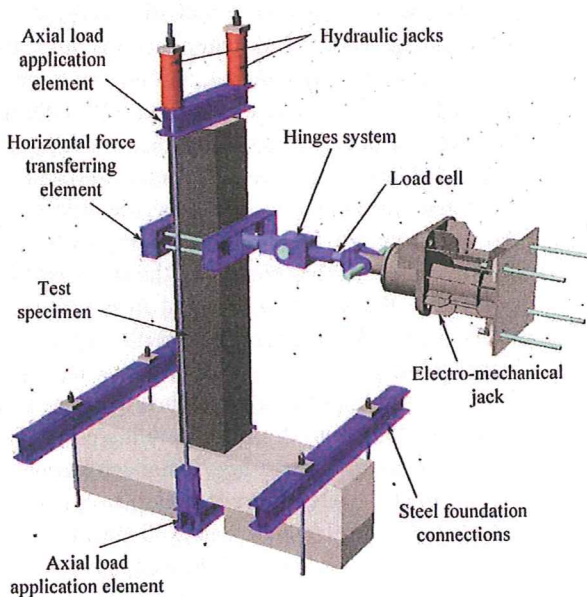
Fig. 4: Test setup

The specimen was placed on the testing frame and an axial load equal to 38,220 lbf (170 kN) was applied by means of two hydraulic jacks (Fig. 4). This axial load was designed to reproduce the effect of the dead loads acting on the column at the time of the jacket application.

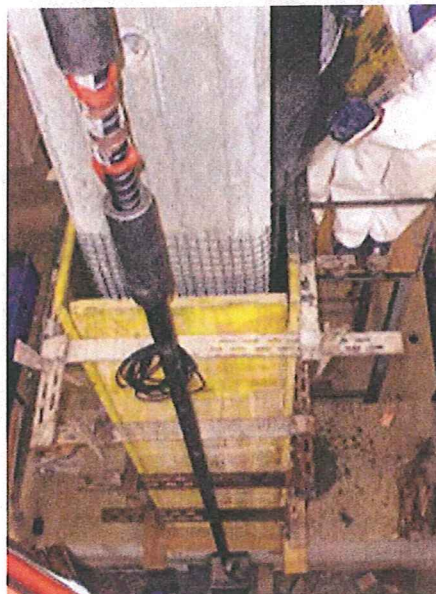
Fig. 5: High-performance jacket casting

The strengthening jacket with a thickness of 1.6 in. (40 mm) was eventually cast (Fig. 5) with a self-consolidating high-performance fiber-reinforced concrete with a compressive strength of 18,855 psi (130 MPa) and a tensile strength of 870 psi (6 MPa). To connect the jacket to the column base, a pocket 2 in. (50 mm) deep was created in the foundation and a high-strength steel mesh 0.08 in. (2 mm)

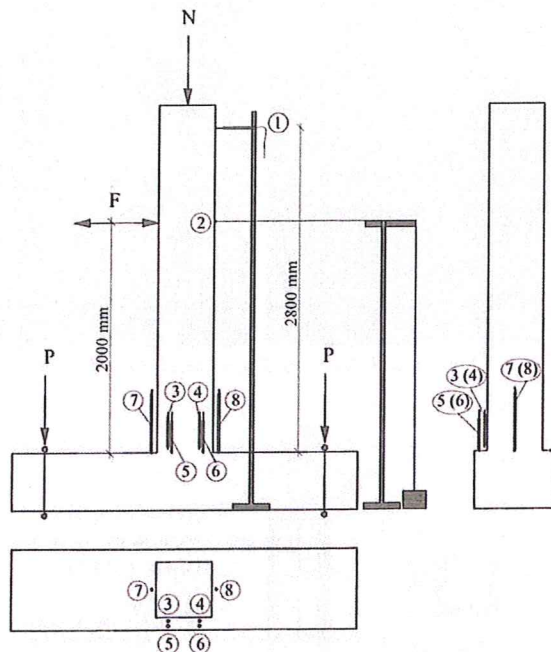
Fig. 6: Displacement measurement setup. (Note: 1 mm = 0.039 in.)

To measure the horizontal displacements, potentiometric transducers were placed on the column top (Position 1 in Fig. 6) and at the level of the load application (Position 2 in Fig. 6). The rotations at the column base were measured by means of a series of potentiometric transducers. The devices in Position 3-4-7-8 of Fig. 6 were placed on the column, whereas the devices in Position 5-6 of Fig. 6 were placed to measure the relative displacement between the column and foundation base.

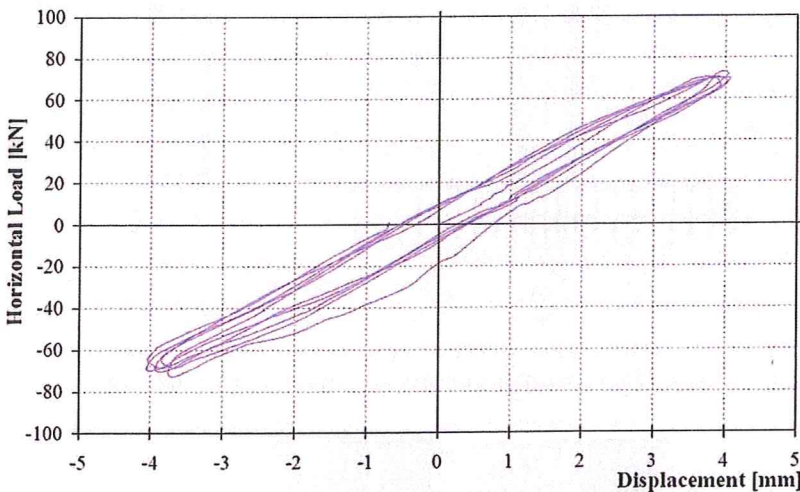
Fig. 7: Horizontal load versus displacement for the design load level. (Note: 1 mm = 0.039 in.; 1 kN = 225 lb)

Initially, a cyclic horizontal force and a constant vertical force were applied to simulate the maximum design actions (axial force  $N = 145,000$  lbf [645 kN], bending moment  $M = 106,210$  ft-lb [144 kN-m], and shear force  $V = 16,186$  lbf [72 kN]). In this testing phase, five cycles were performed by applying maximum design bending moment and shear action in both directions with a constant axial force. Under these actions, there did not appear to be any damage, and no cracks were detected on the strengthening jacket for the column. As observed in Fig. 7, where the horizontal force-versus-displacement curve is presented, the behavior is almost linear elastic and only the first cycle showed some settlement of the loading system.

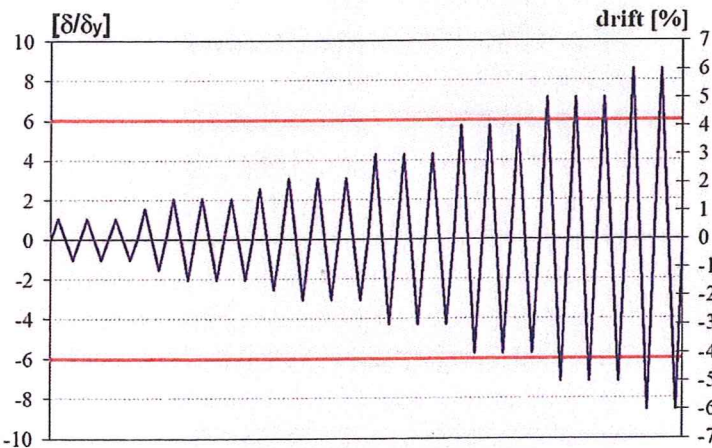
Fig. 8: Load history

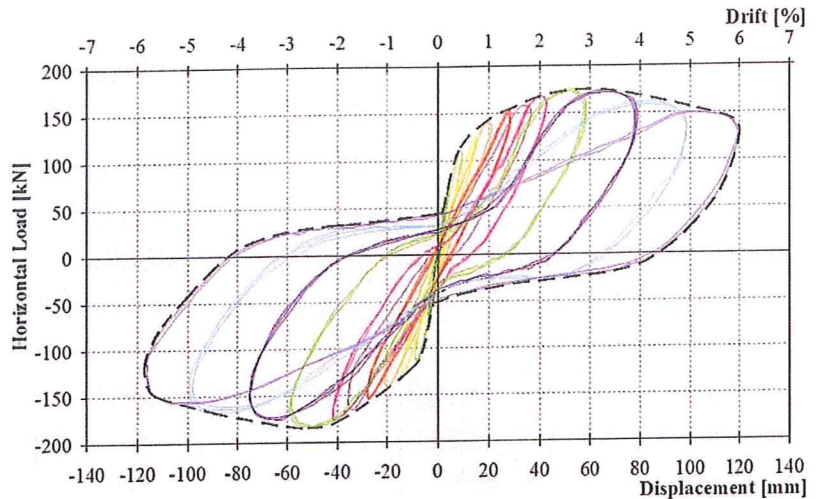
Fig. 9: Horizontal load versus displacement at the load application point. (Note: 1 mm = 0.039 in.; 1 kN = 225 lb)

The results of horizontal load versus displacement at the level of the load application point are shown in Fig. 9. The column reached collapse during the third cycle at a drift level equal to 6% (4.7 in. [120 mm];  $\delta/\delta_y = 8.6$ ). The collapse was due to the rupture of one of the longitudinal reinforcing steel bars.

The envelope curve (dotted line) in Fig. 9 indicates strength degradation for drift levels higher than 3.5%. The maximum bearing capacity is equal to 39,340 lbf (175 kN), whereas the horizontal load at failure is equal to 32,600 lbf (145 kN)—83% of

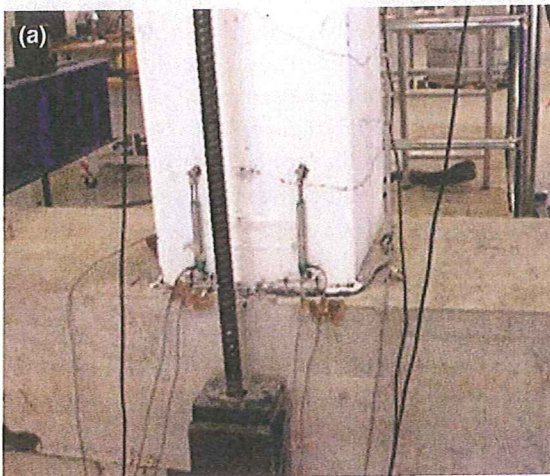
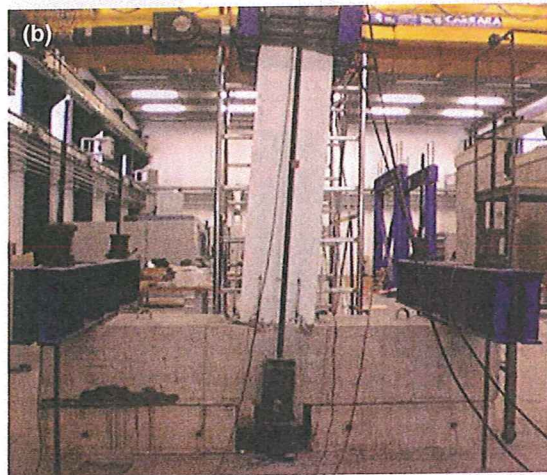
Fig. 10: (a) Cracking at the column base; and (b) column deformation at failure

After the onset of the flexural cracking at a drift equal to 1%, the behavior was stable up to failure with limited damage. The main crack was located near the end of the high-strength steel mesh that was intended to link the high-performance concrete jacket to the base foundation. Other cracks developed with a spacing of about 11.8 in. (300 mm), which was equal to the stirrup spacing.

Figure 10(a) shows the crack pattern at failure. Notice the localized damage in relation to the jacket-foundation interface. Figure 10(b) shows the column deformation at a 6% drift.

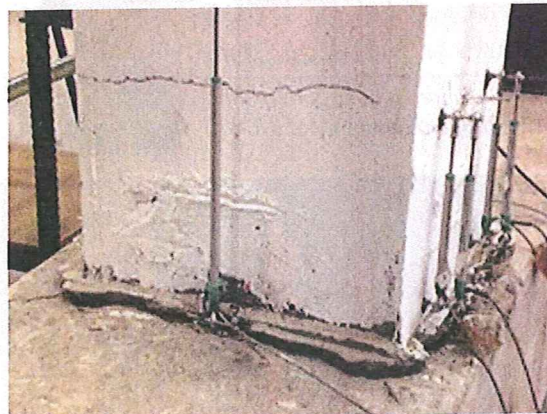
Fig. 11: Slip between jacket and foundation base

the maximum load. The load decrease can be justified because of a progressive slip of the jacket at the foundation base, as shown in Fig. 11.

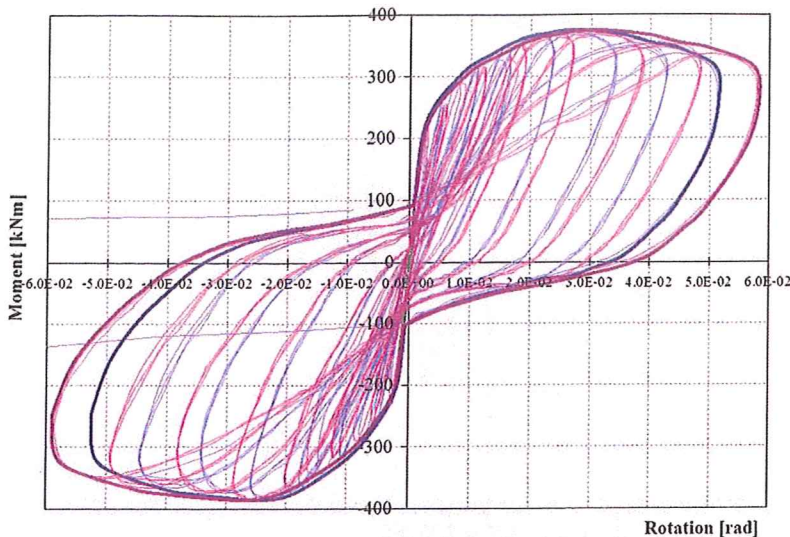
Fig. 12: Moment-versus-rotation curves with and without slip contribution. (Note: 1 mm = 0.039 in.; 1 kNm = 737.5 lbf)

This slip is confirmed in Fig. 12, where the moment-versus-curvature curves at the column base are drawn. In one curve, the curvature was determined by reading the displacement transducers placed on the column, whereas the other curve was determined by reading the transducers measuring the relative displacement between the column and foundation. As a result, the first curve

does not take into account the jacket slip as the second curve does. The two curves tend to diverge with the slip mechanism activation after the maximum moment (horizontal force) is reached. This aspect justifies the load decrease at 3.5% of drift.

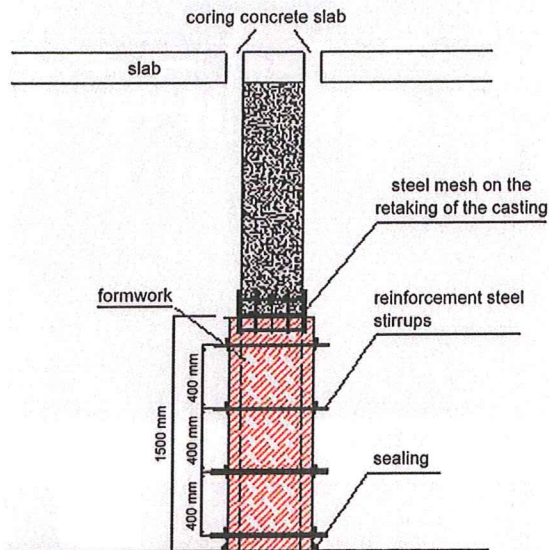
Fig. 13: Diagram of Zagarolo School column-strengthening techniques. (Note: 1 mm = 0.039 in.)

This article illustrates the first application of a new strengthening technique based on the use of high-performance fiber-reinforced concrete. Given the favorable results obtained during this research, application of the new technique was conducted on columns at the job site in Zagarolo (Fig. 13 to 15).

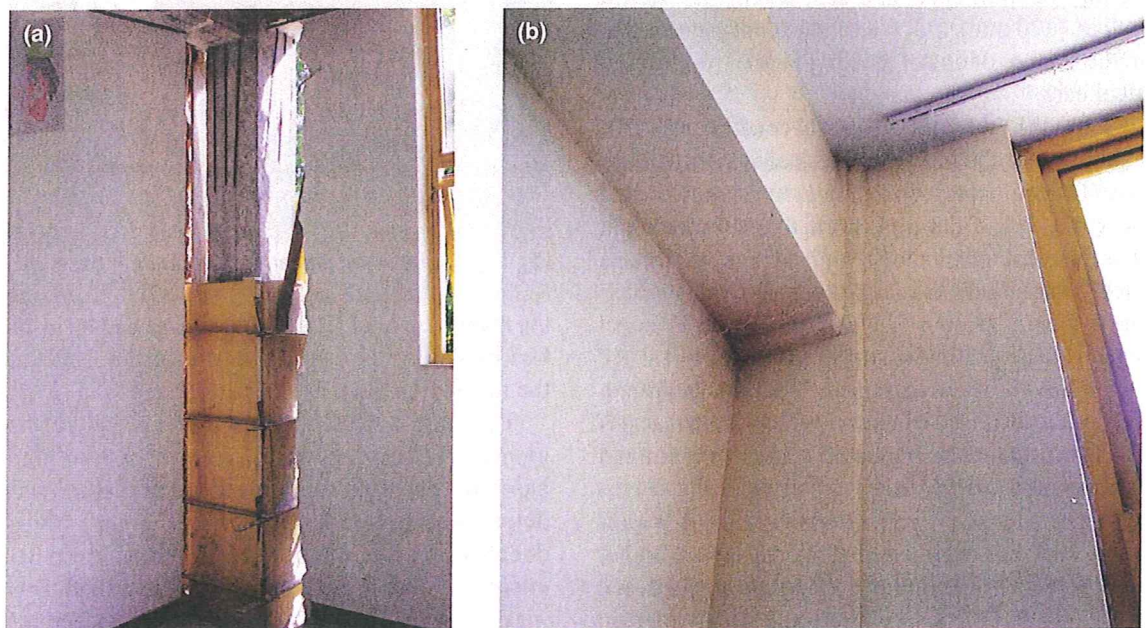
Fig. 14: (a) Strengthening repairs in progress; and (b) completed repairs

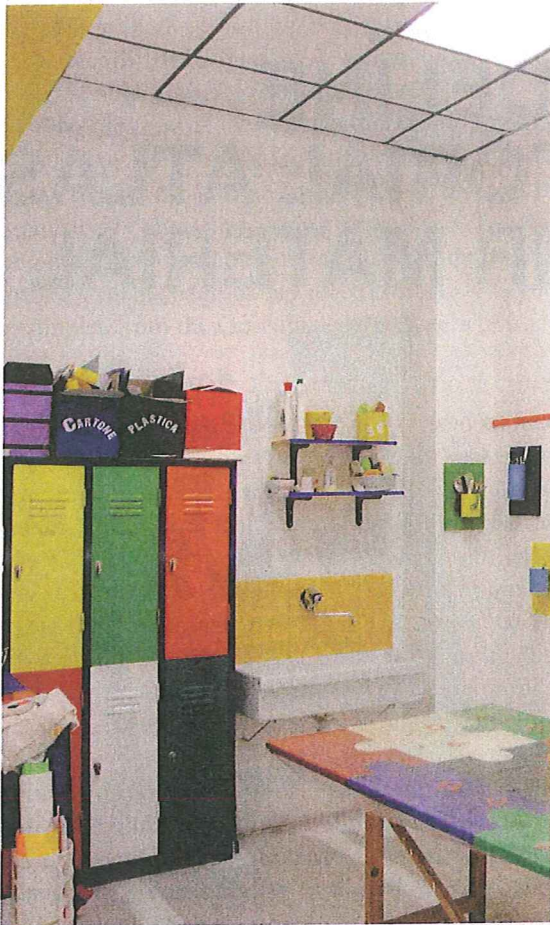
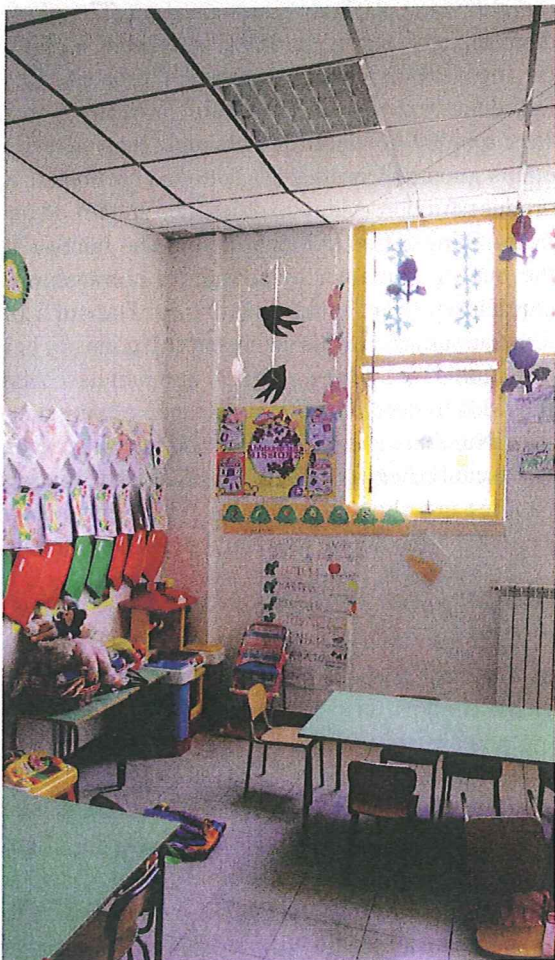
Fig. 15: Completed repairs
